## Check Out Document

Address	4 Pebble Drive Didcot Oxfordshire OX11 9RE	House Type	Flat/Apartment
		Detachment	N/A
Front Elevation		Side Elevation	Rear Elevation

25/04/2023

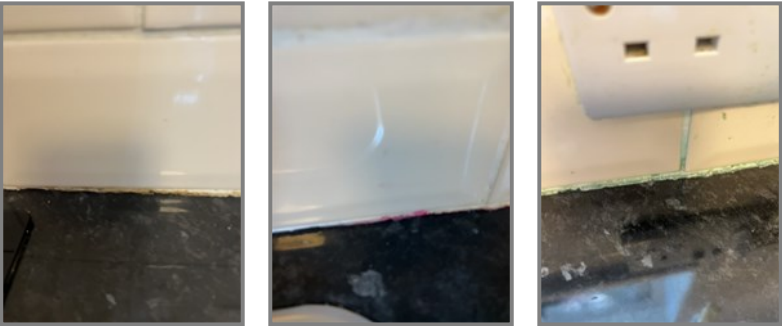
Problem Identified	Sealant to kitchen worktop is discoloured		
Person Responsible if Known			
Photos

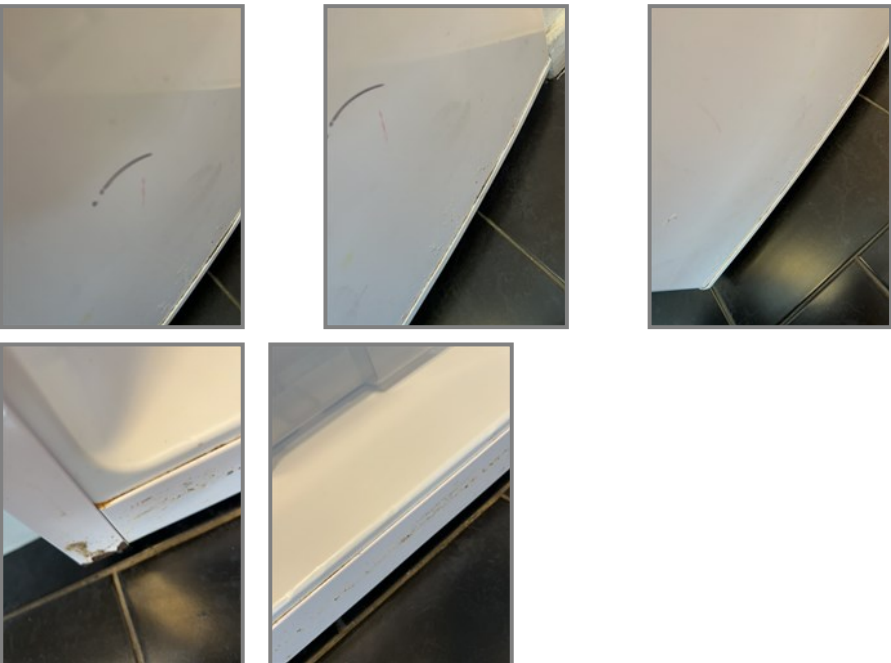
Problem Identified	Fridge door is rusting and has pen marks		
Person Responsible if Known			
Photos

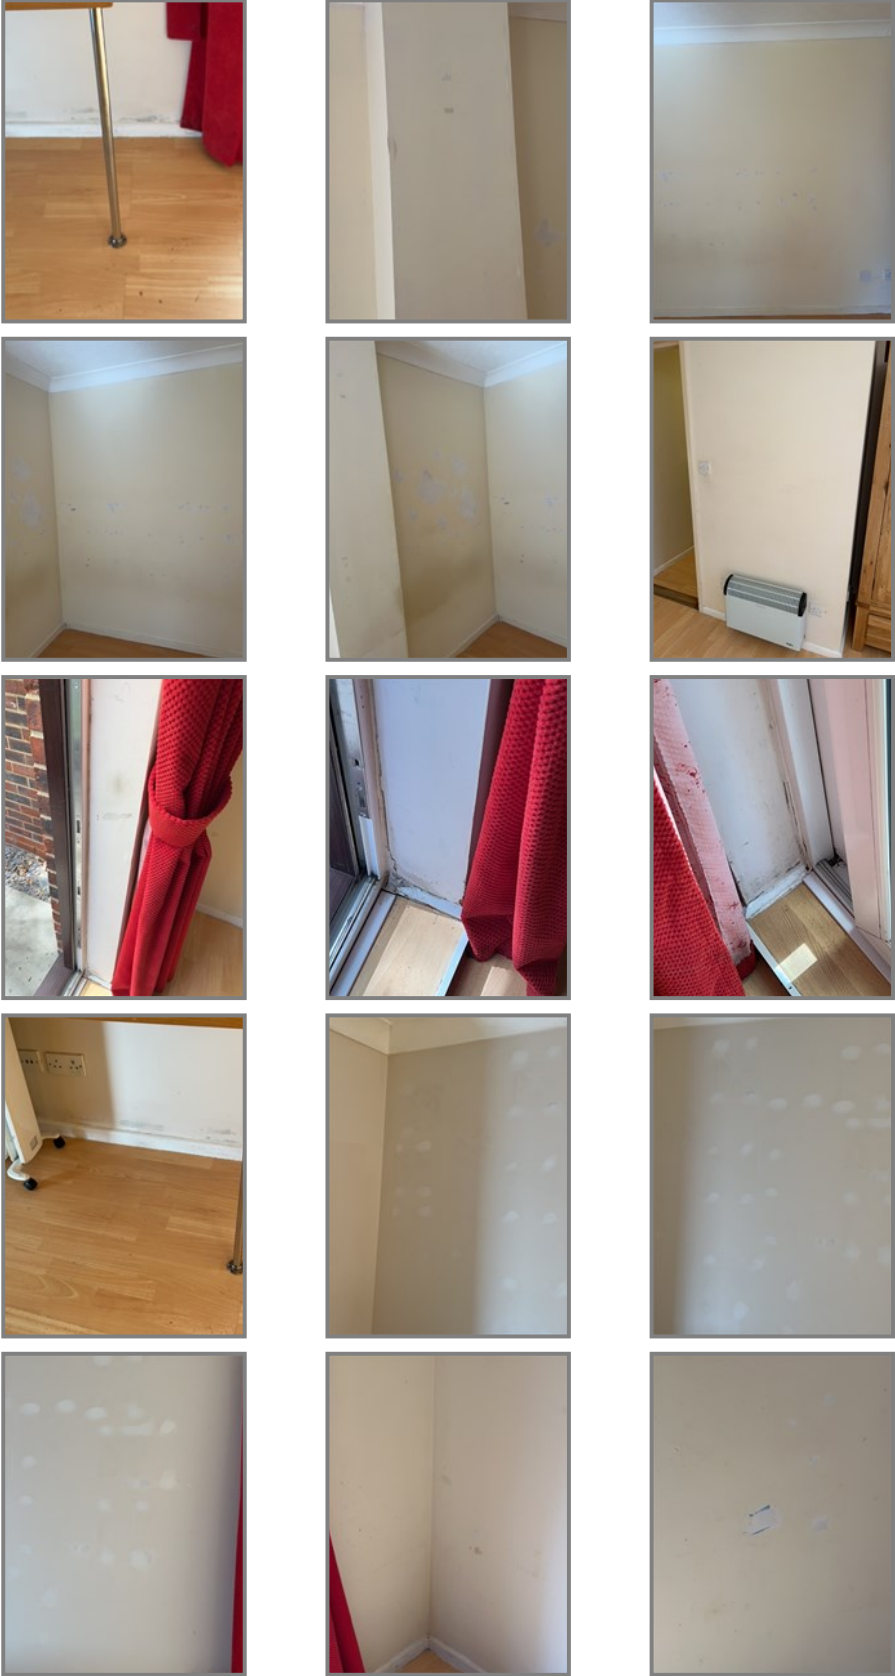
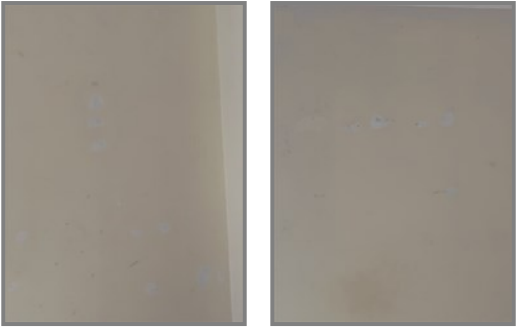
Problem Identified	Many filled holes throughout living room, mould spots below wooden breakfast bar, many sticky residue marks throughout. Mould spots and peeling paint around patio doors		
Person Responsible if Known			
Photos

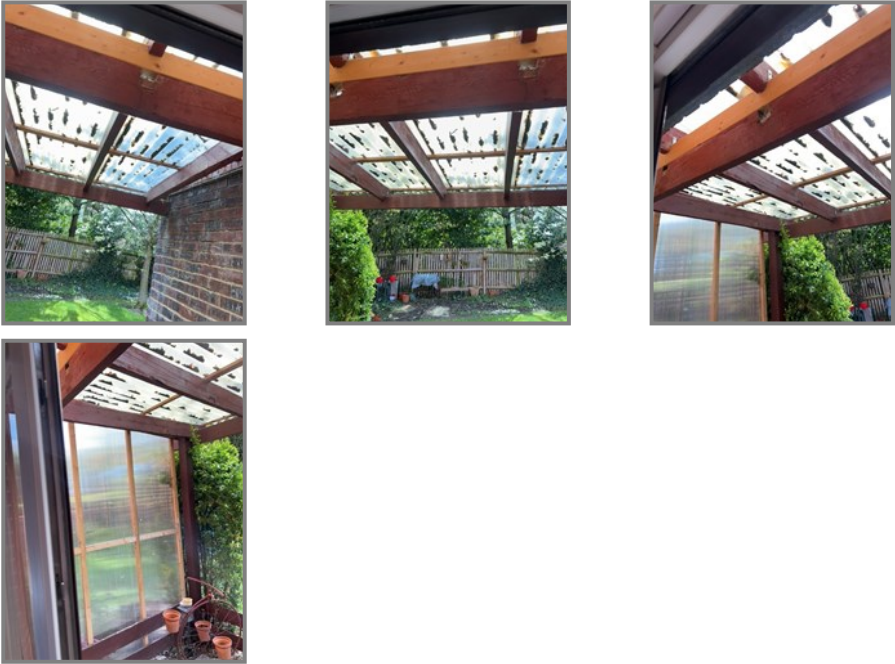
Problem Identified	Tenant added a roof over patio
Person Responsible if Known	
Photos
